12/14/94 Phoenix Air Group, Inc.

Official Accident Report Index Page

CRASH DURING EMERGENCY LANDING
PHOENIX AIR LEARJET 35A, N521PA FRESNO,
CALIFORNIA DECEMBER 14, 1994

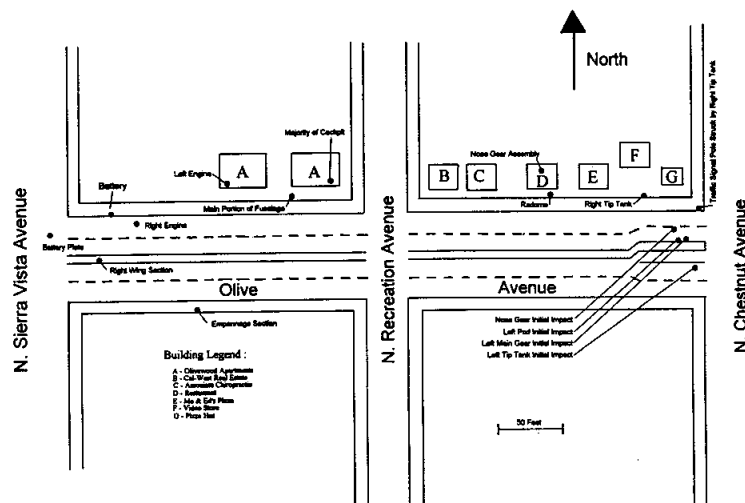
Figure 2c.--Wreckage path diagram.

Portions of the airplane, including the right wing, right engine, and empennage, came to rest on E. Olive. A substantial portion of the fuselage was consumed in fires located in and around the apartment buildings and associated foliage. The left engine came to rest in an unburned apartment unit.

The ground fire was most severe along the north side of E. Olive, between N. Recreation and N. Sierra Vista. The remains of the left wing were combined with fuselage structure and found inverted in debris to the north side of E. Olive between the **south**-facing sides of the impacted apartment buildings. Most of the aluminum structure was melted, and the left wing was barely recognizable, except for the remaining steel components. Twelve vehicles, parked along the north curb of E. Olive, between N. Recreation and N. Sierra Vista, were ignited and destroyed by fire. Damage to structures along the **south** side of E. Olive was generally restricted to flash burns.

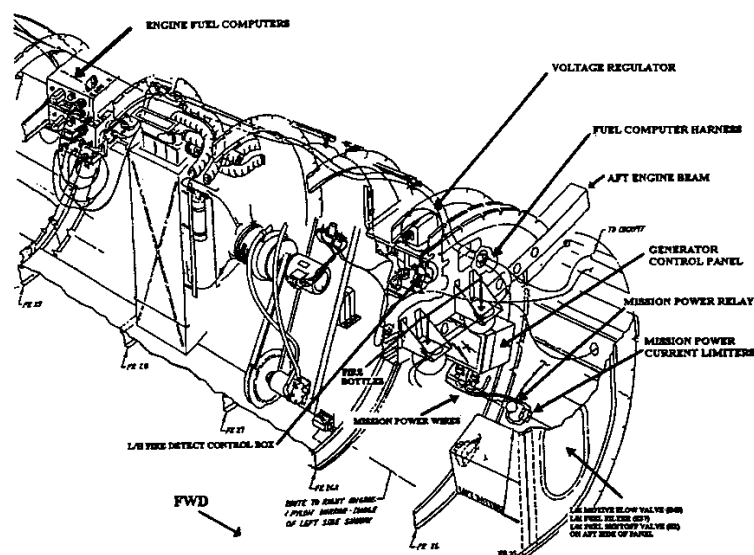
Figure 3a.--Components in tailcone.

The investigation found that in the actual mission equipment wiring of N521PA, the power wires were routed directly to the battery charging bus. (Figure 3a is a drawing of major components in the tailcone. Figure 3b shows the intended versus actual routing of the power wires in N521PA.)

The evidence found in the wreckage showed that the electrical power cables for the special mission equipment had not been installed in accordance with specifications. The improper installation left portions of the wires unprotected by current limiters. The two large-diameter DC power wires that were retrieved from the wreckage showed evidence of arcing and they were "welded" together in the area unprotected by the current limiters. This evidence indicates shorting and unlimited current flow for an extended period of time while the airplane was airborne.

The investigation revealed that the proper installation specified that the special mission wires were to be attached to fittings in the generator control panel, where they would have been protected from overload during shorts by current limiters. Instead, the wires had been routed directly from the battery charging bus to 150 amp limiters before being routed to the control relay. Segments of the wires were unprotected by current limiters for about 18 inches, and they were found fused together between the battery bus and the current limiters. As a result of the wiring arrangement, large amounts of current could travel to the ground.

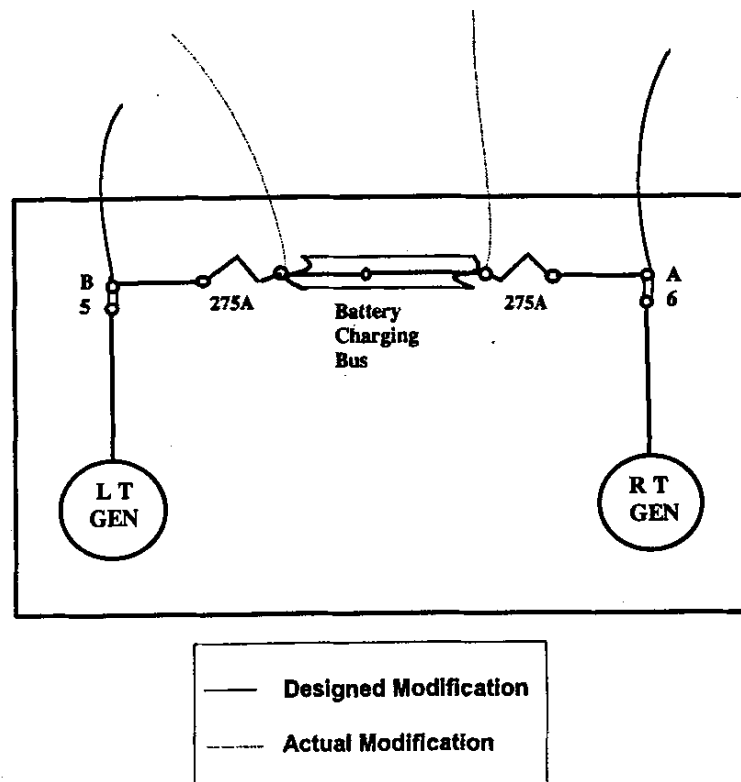
Figure 3b.--Mission power wiring.

Fire damage to the wire insulation precluded a determination of the reasons for the shorting of the wires; however, one of these wires may have been frayed, and a short to ground (probably an airplane frame) occurred. Nevertheless, the evidence is conclusive that while the airplane was airborne, a severe short occurred on the left side of the aft fuselage in the electronics bay. Without the protection of the current limiters, the short was not interrupted.

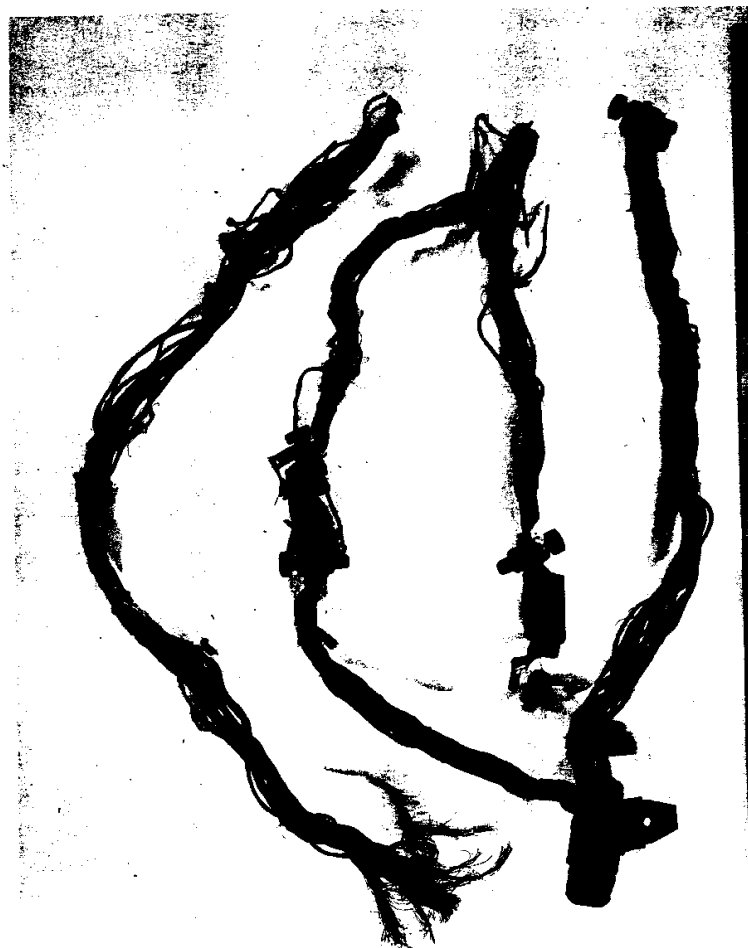
Figure 4.--View of cables as received for examination.

Portions of the wires, identified as part of the electrical power source for the special mission package, were size No. 0 awg and were found on E. Olive, near the wheel of an unburned vehicle. The wires had evidence of high heating prior to impact, including areas fused together for about 2 inches in length, and individual strands of the wires had a beaded appearance. [\(See figure 4.\)](#) Current limiters (fuses) were found attached to the nonwelded ends of one of the two sets of wires. In subsequent testing, the current limiters were found to provide electrical continuity (in the closed position).
